SOLID POLYMER MEMBRANE PROGRAM

Final Report

Contract NAS 9-11876

GENERAL ELECTRIC

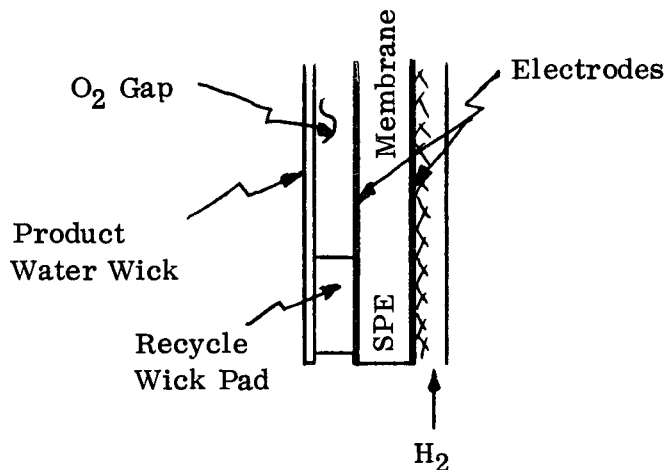
The parametric test program identified the hydrogen inlet water condition as the major parameter affecting membrane degradation/delamination. The life test base line cells utilized dry reactant, whereas other life test cells utilized prehumidified hydrogen and/or water recycle wick pads. See sketch below.

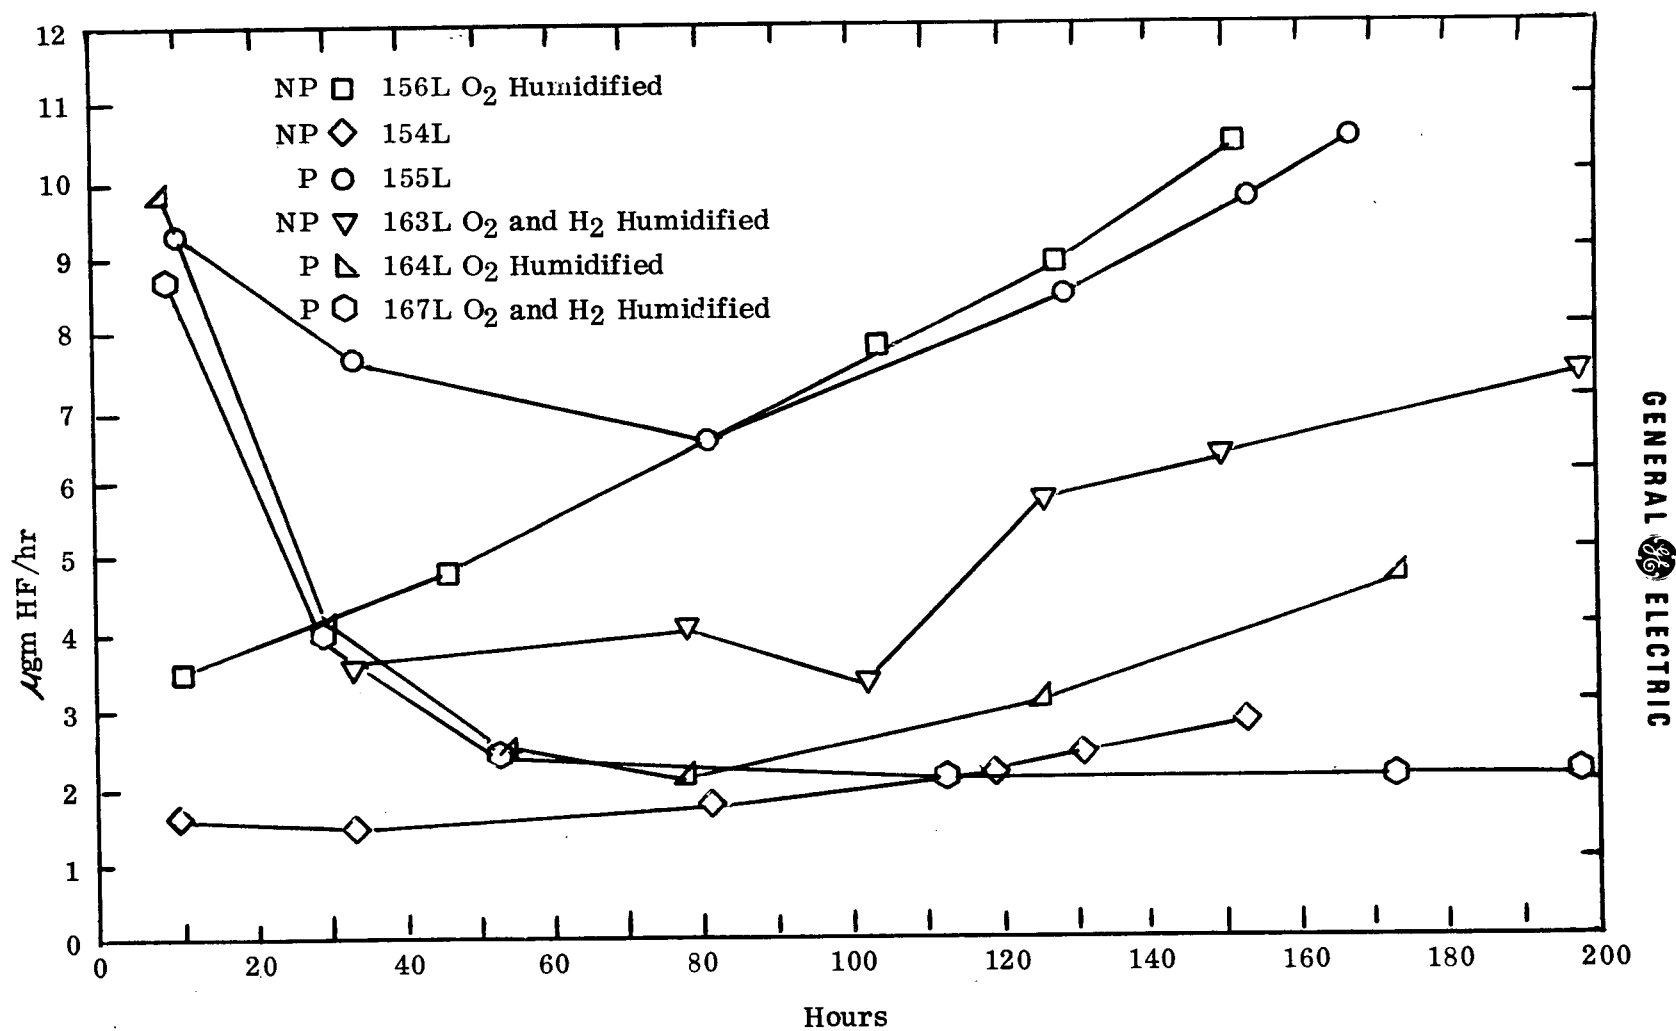
Figure 2. Group No. 1 Test Cells - Fluoride Release

At the 234 hour point, the O₂ prehumidifier was shut off on Cell 163L and operation continued for a total of 401 hours. Only slight delamination was identified on this cell.

Cell 167L stabilized at the lowest HF release rate of any of the Group No. 1 cells and was terminated at 210 hours. No evidence of degradation or delamination was observed on this cell.
